Aesthetic Management of Fractured Anteriors: A Case Report

Case Report: In our case, an economical and time-saving novel technique has been described for direct composite restoration in a young patient with uncomplicated fractured maxillary anterior tooth.

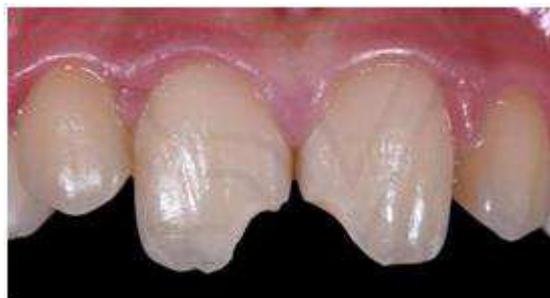
Figure-1: Pre operative view 11 and 21

A 12-year-old boy was reported to our Paediatric Dental clinic for the treatment of fractured upper front teeth with esthetic concern. Patient gave history of trauma 6 months back due to fall from a bicycle. Clinical examination revealed Ellis class II (uncomplicated) fracture in relation to 11 and 21 Figure-1 .The tooth was asymptomatic without any associated soft or hard tissue injuries to the supporting tissues. Intraoral periapical radiograph confirms the absence of pulpal or periapical pathosis. Therefore, a direct composite restoration technique was planned for restoration of the fractured segment. Figure-2.

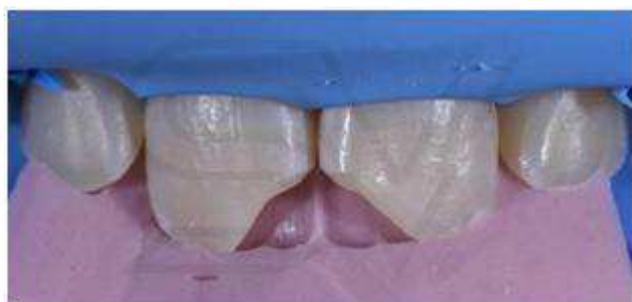
Figure-2: Intra oral view with putty template

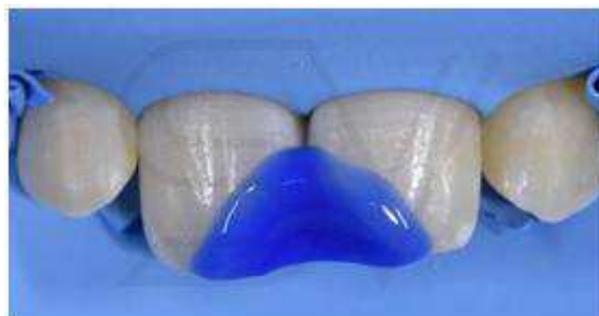
Figure 3 – Acid etching beyond the bevel.11 and 21

The treatment procedure was performed as follows: a bevel was placed on the whole facial surface, beginning from the gingival margin, to allow for a gradual increase in the thickness of the resin composite. Incisal edges and corners were rounded and the bevel was extended to a 1 mm periphery on the palatal surface. A diamond bur was utilized on the enamel surface while the dentin was cleaned with tungsten carbide burs. The remaining enamel and dentin surfaces were irregular and scalloped. The enamel was etched with 37% phosphoric for 15 seconds and rinsed thoroughly with water. Excess water was removed with an air syringe. Figure-4

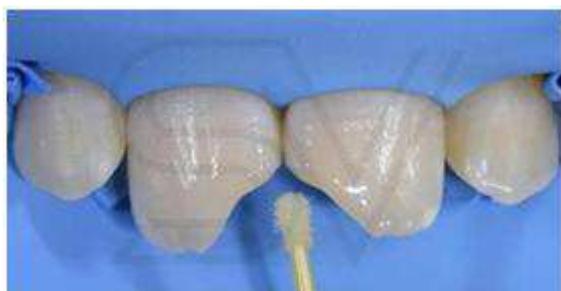
Figure 4: Bonding agents11 and 21

The teeth were restored using a twostep self-etch adhesive system. The primer was applied to the cavity and gently dried with an air syringe for five seconds. Figure-5

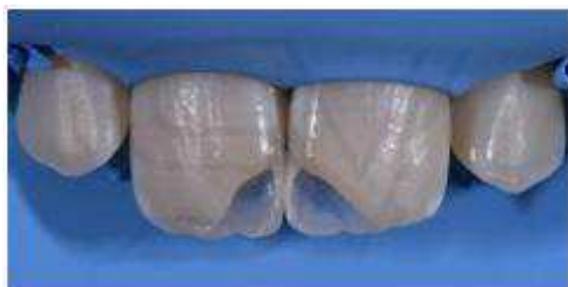
Figure 5: Incisal enamel shape was inserted 11 and 21

Adhesive was then applied to the enamel and dentin and the preparation was gently air dried for five seconds, leaving a shiny surface. The adhesive was then light polymerized for 20 seconds. Figure-5. The teeth were restored with Estelite Omega resin composite(Tokuyama dental America). Figure-6, Figure-7, All restorations were finished and polished using an extra-fine finishing bur and rubber polishing bur. Finally, the restorations were checked for any traumatic occlusal adjustment. The follow-up visit after 11 months showed that the edges and marginal adaptation of the restoration were still good. Figure-8, Figure-9.

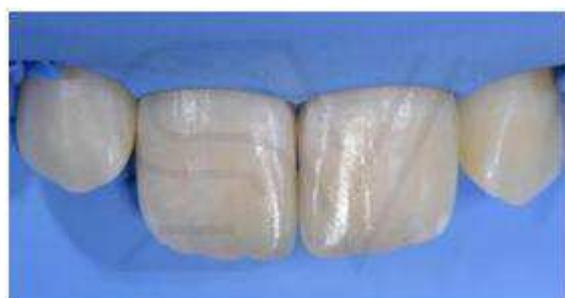
Figure 6: Final layer, Color intensifiers11 and 21

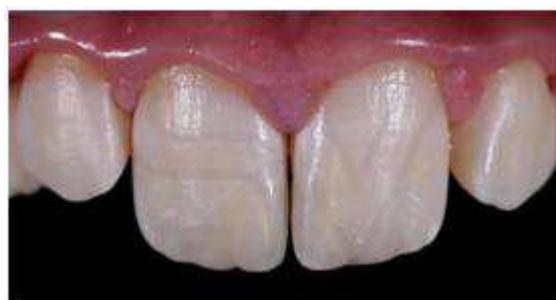
Figure 7: The restoration surfaces were polished with finishing discs

The finishing and polishing process can affect many aspects of the final restoration, including surface staining, plaque accumulation and wear characteristics of the resin composite. Therefore, finishing and polishing procedures are of primary importance in terms of esthetics and clinical success of the restoration.[2,3,4,14,15] Figure-7, Figure-8.

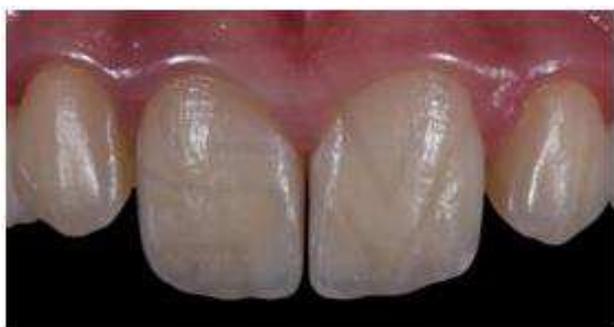
Figure 8: Final view of restoration11 and 21

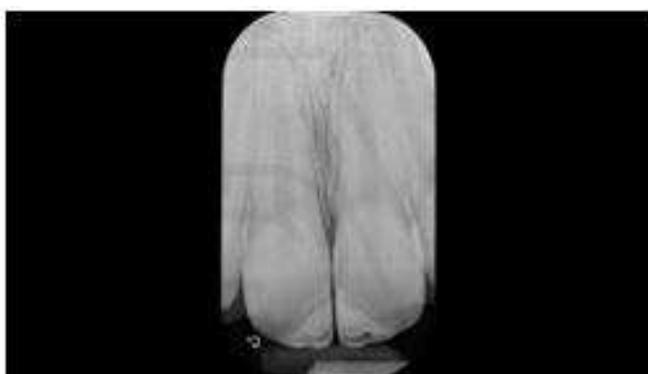
Figure 9: Post-operative periapical radiograph
